DEPARTMENT OF TRANSPORTATION

Quality Assurance and Source Inspection

Contract #: 04-0120F4Cty: SF/ALA Rte: 80 PM: 13.2/13.9File #: 69.28**WELDING INSPECTION REPORT****Resident Engineer:** Pursell, Gary**Address:** 333 Burma Road**City:** Oakland, CA 94607**Report No:** WIR-003233**Date Inspected:** 13-Jul-2008**Project Name:** SAS Superstructure**OSM Arrival Time:** 1400**Prime Contractor:** American Bridge/Fluor Enterprises, a JV**OSM Departure Time:** 2300**Contractor:** Zhenhua Port Machinery Company, Ltd (ZPMC), Changxing Island **Location:** Shanghai China

Bridge No: 34-0006**Component:** OBG side, bottom, deck panels, floor beams a**Summary of Items Observed:**

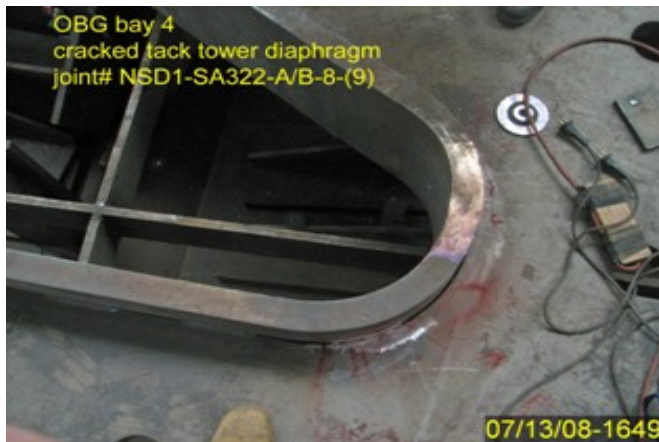
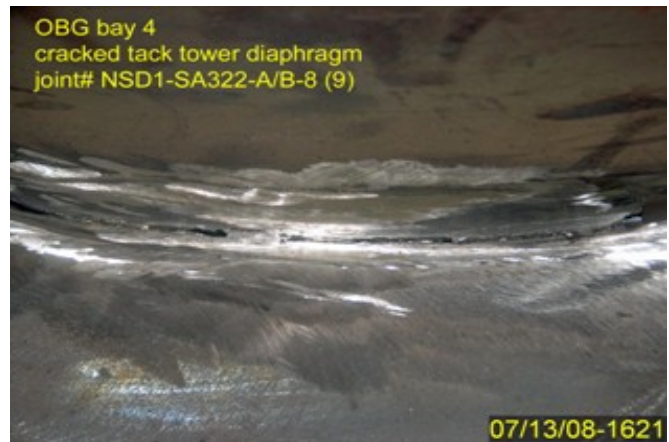
QA was notified by ZPMC QA identified as Mr. Lei Tao of a cracked tack on tower diaphragm weld# NSD1-SA322A/B-8 (9). QA observed ZPMC personnel excavate the broke tack by grinding and ZPMC QC MT'ed the excavated area. MT appeared to comply with AWS D1.5 2002 and the contract documents.(see digital photos below)
